Manhole Inspection Summary

Manhole # S07EE2021MH

Insp Date: **7/18/06 10:37 AM**

Location Address: **6106 GREENSPRING AVE**

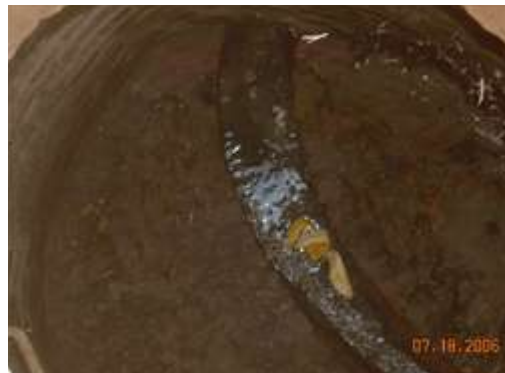
Top View

Frame leaks. Bench debris. Channel debris.

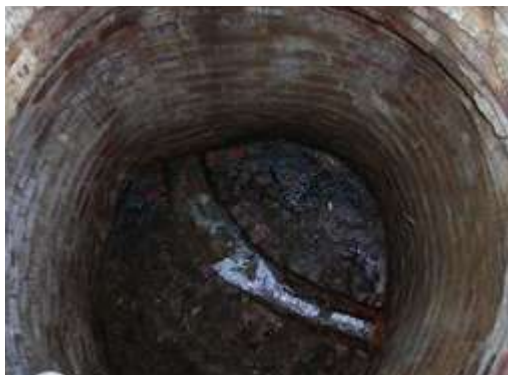
Top View

Bench debris. Channel debris. Adjustment and Barrel infiltration

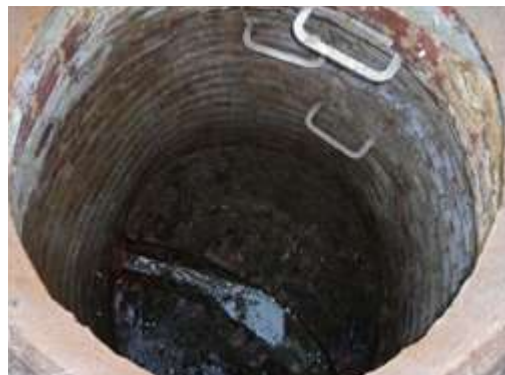
Defect

Comments **I5 picture indicates evidence of infiltration through the mortar of the barrel wall.**

Bench debris. Adjustment and Barrel infiltration

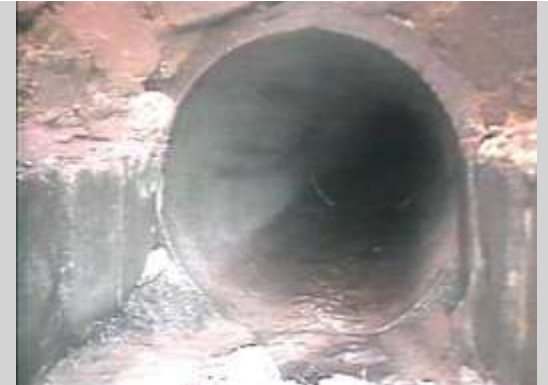
8 in. Circular Gravity Sewer Pipe Out @ 12 O'Clock

Deposits: ☒ None ☐ Mud ☐ Sludge ☐ Debris ☐ Grease

Infiltration: **None** Pipe Seal Cond: **Unknown**

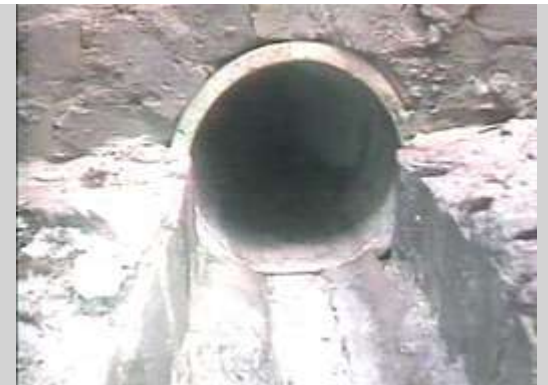
8 in. Circular Gravity Sewer Pipe In @ 5 O'Clock

Deposits: ☒ None ☐ Mud ☐ Sludge ☐ Debris ☐ Grease

Infiltration: **None** Pipe Seal Cond: **Unknown**
